Optimization of the removal of wafer backside defects arising from electrostatic clamping during ion implantation by scrubber processing with acidic chemical

SCREEN Semiconductor Solutions Co., Ltd.

Axcelis Technologies Inc.,

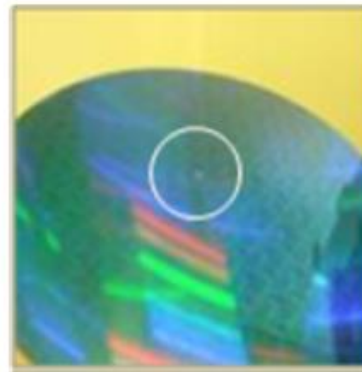
- ◆ **Impact of backside particles on frontside patterning**
 - Focus-spot failures in lithography become more critical in advanced logic nodes and 3D stacked memory devices.

Wafer map of pattern defects

Optical image of pattern defect

SEM image of pattern failures

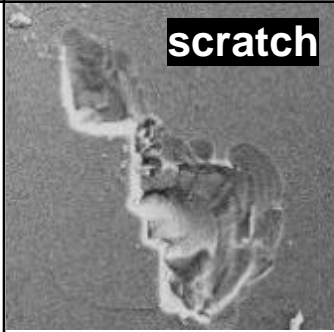
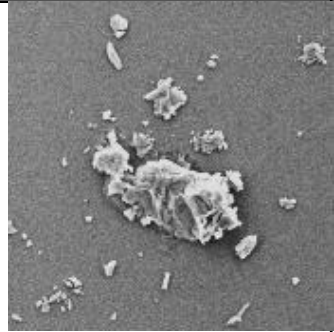
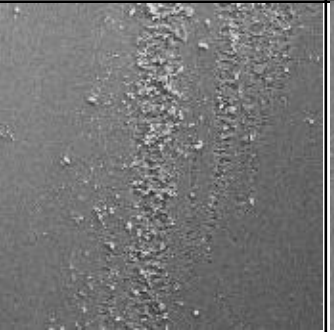
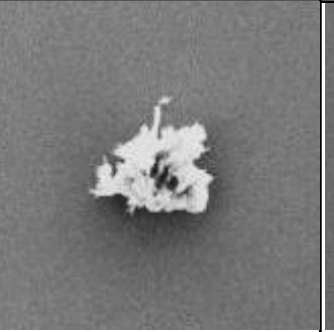
Identification of ESC defects

Mesa	Gas ring	BSG inlet	In air end effector
SEM

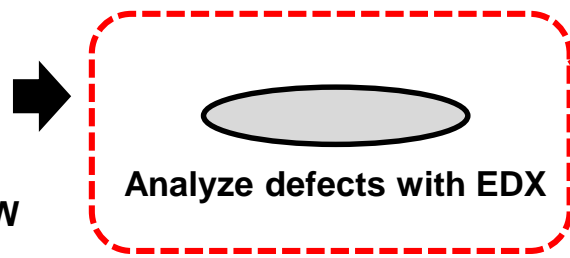
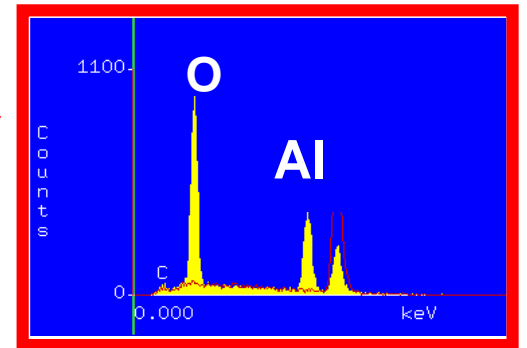
EDX

Al and O still detected

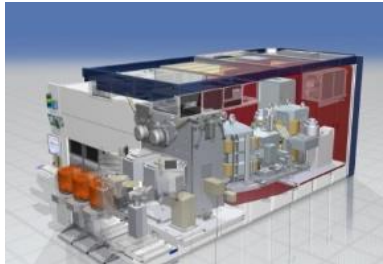
- Implant process can generate backside particles due to electrostatic clamping. SCREEN cleans the wafers and confirms defects removal efficiency with 1.0 μm particle size, SEM inspection and EDX analysis.

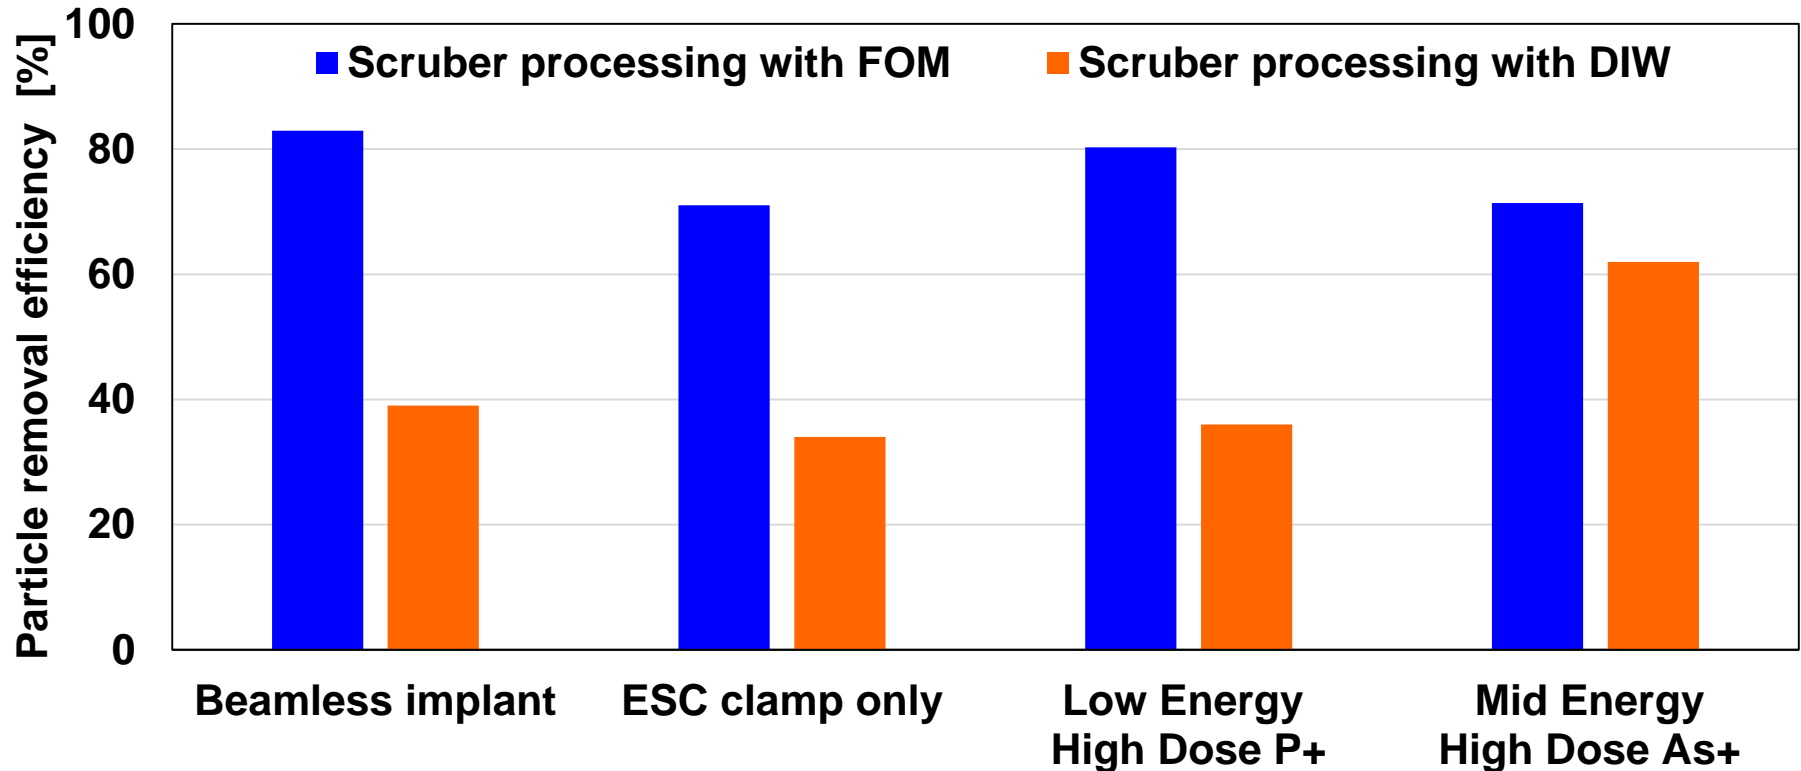
◆ ESC defect removal efficiency

Scrubber processing with FOM could improve 10 - 40% of ESC defect removal efficiency from scrubber processing with DIW at each test condition.

- ◆ **New scrubber processing has been developed to enable efficient removability for SiO and AlN defects, 10 - 40% improvement compared to conventional process.**
- ◆ **New type of ESC has demonstrated backside defect reduction and confirmed effectiveness against scratches related to Mesa contacts.**
- ◆ **Combination of new type ESC with new scrubber processing achieved 90% of ESC defects removal efficiency.**

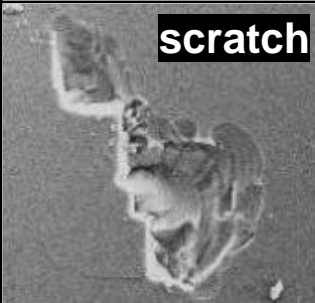
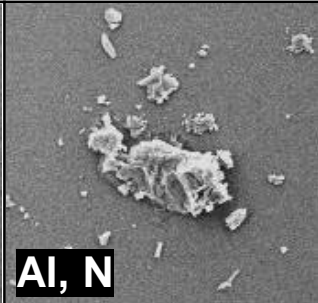
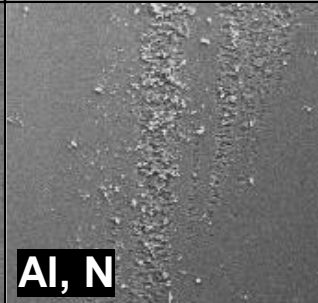
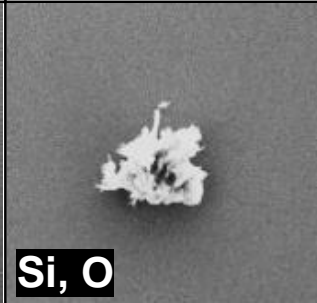
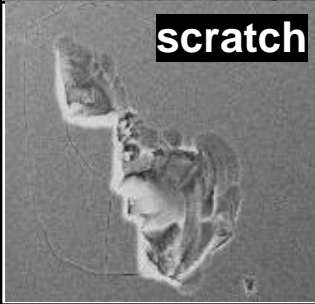
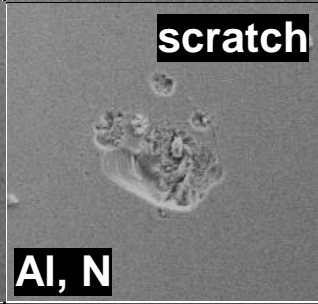
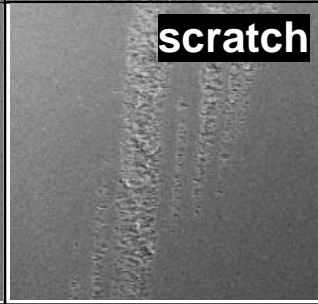
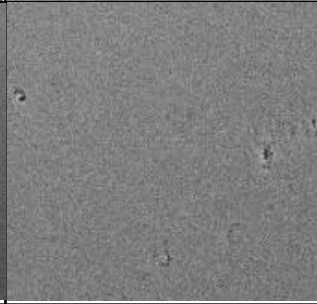
◆ SEM inspection and EDX analysis

Mesa	Gas ring	BSG inlet	In air end effector
SEM	Pre

Post

AlN and SiO defects on wafer could be removed, but there are embedded AlN defect in scratch. Need to reduce the scratches caused by Mesa.

- New type ESC to reduce scratches at mesa

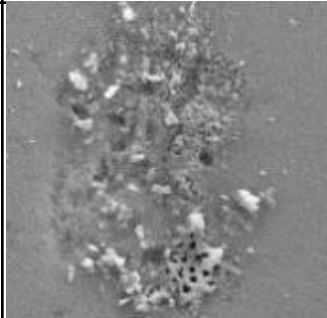
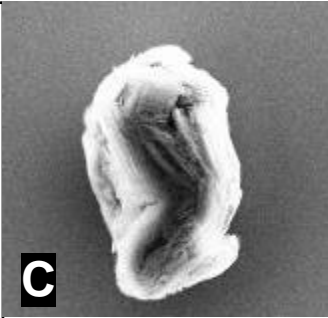
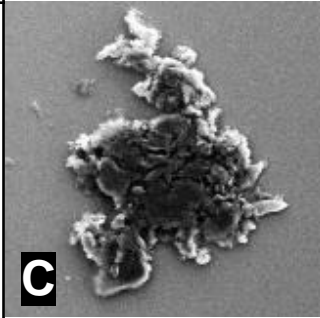
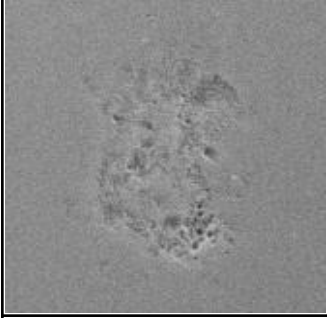
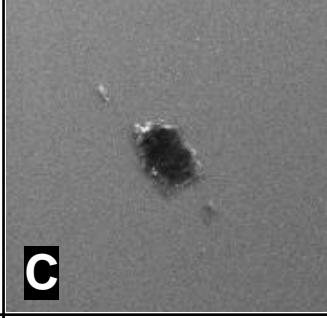
◆ SEM inspection and EDX analysis (Post backside cleaning)

Mesa		Gas ring
SEM	Pre

Post

Carbon defects could be almost removed, but there is small defects remain at Gas ring defect.

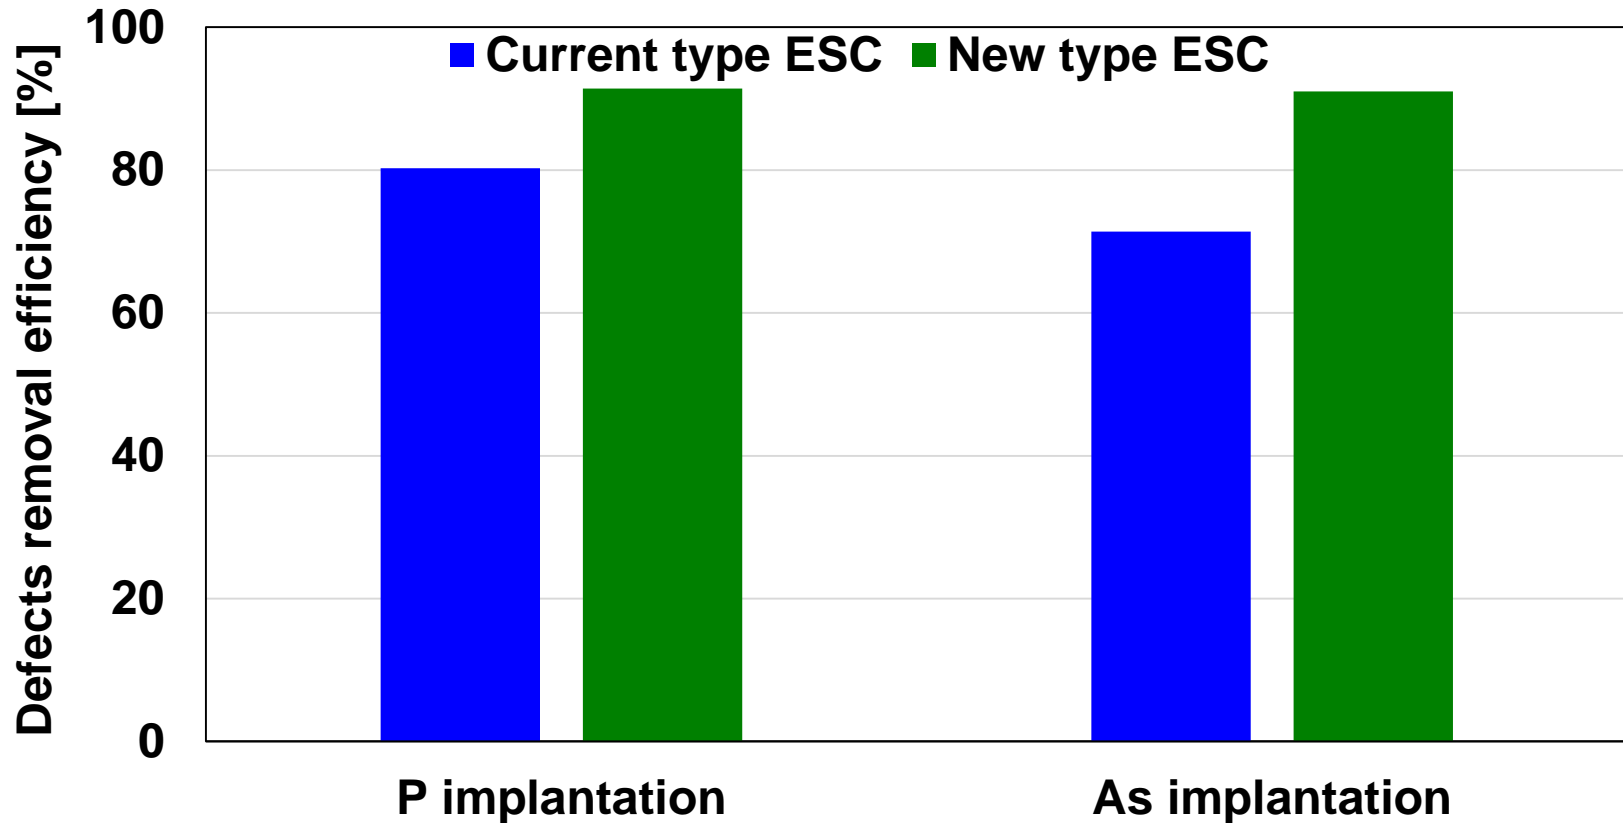
◆ ESC defects removal efficiency

ESC defects removal efficiency is further improved by new type ESC.
